LITIGATION TECHNICAL SUPPORT AND SERVICES
ROCKY MOUNTAIN ARSENAL
DRAFT FINAL VOLUME I
INVENTORY REPORT
POLYCHLORINATED BIPHENYL (PCB)
INVENTORY

Contract No. DAAA05-89-C-0002
September 1990

EBASCO SERVICES INCORPORATED

FIGURE	PAGE
2-1 PCB SAMPLE LOCATIONS - 621B, SALVAGE YARD	12

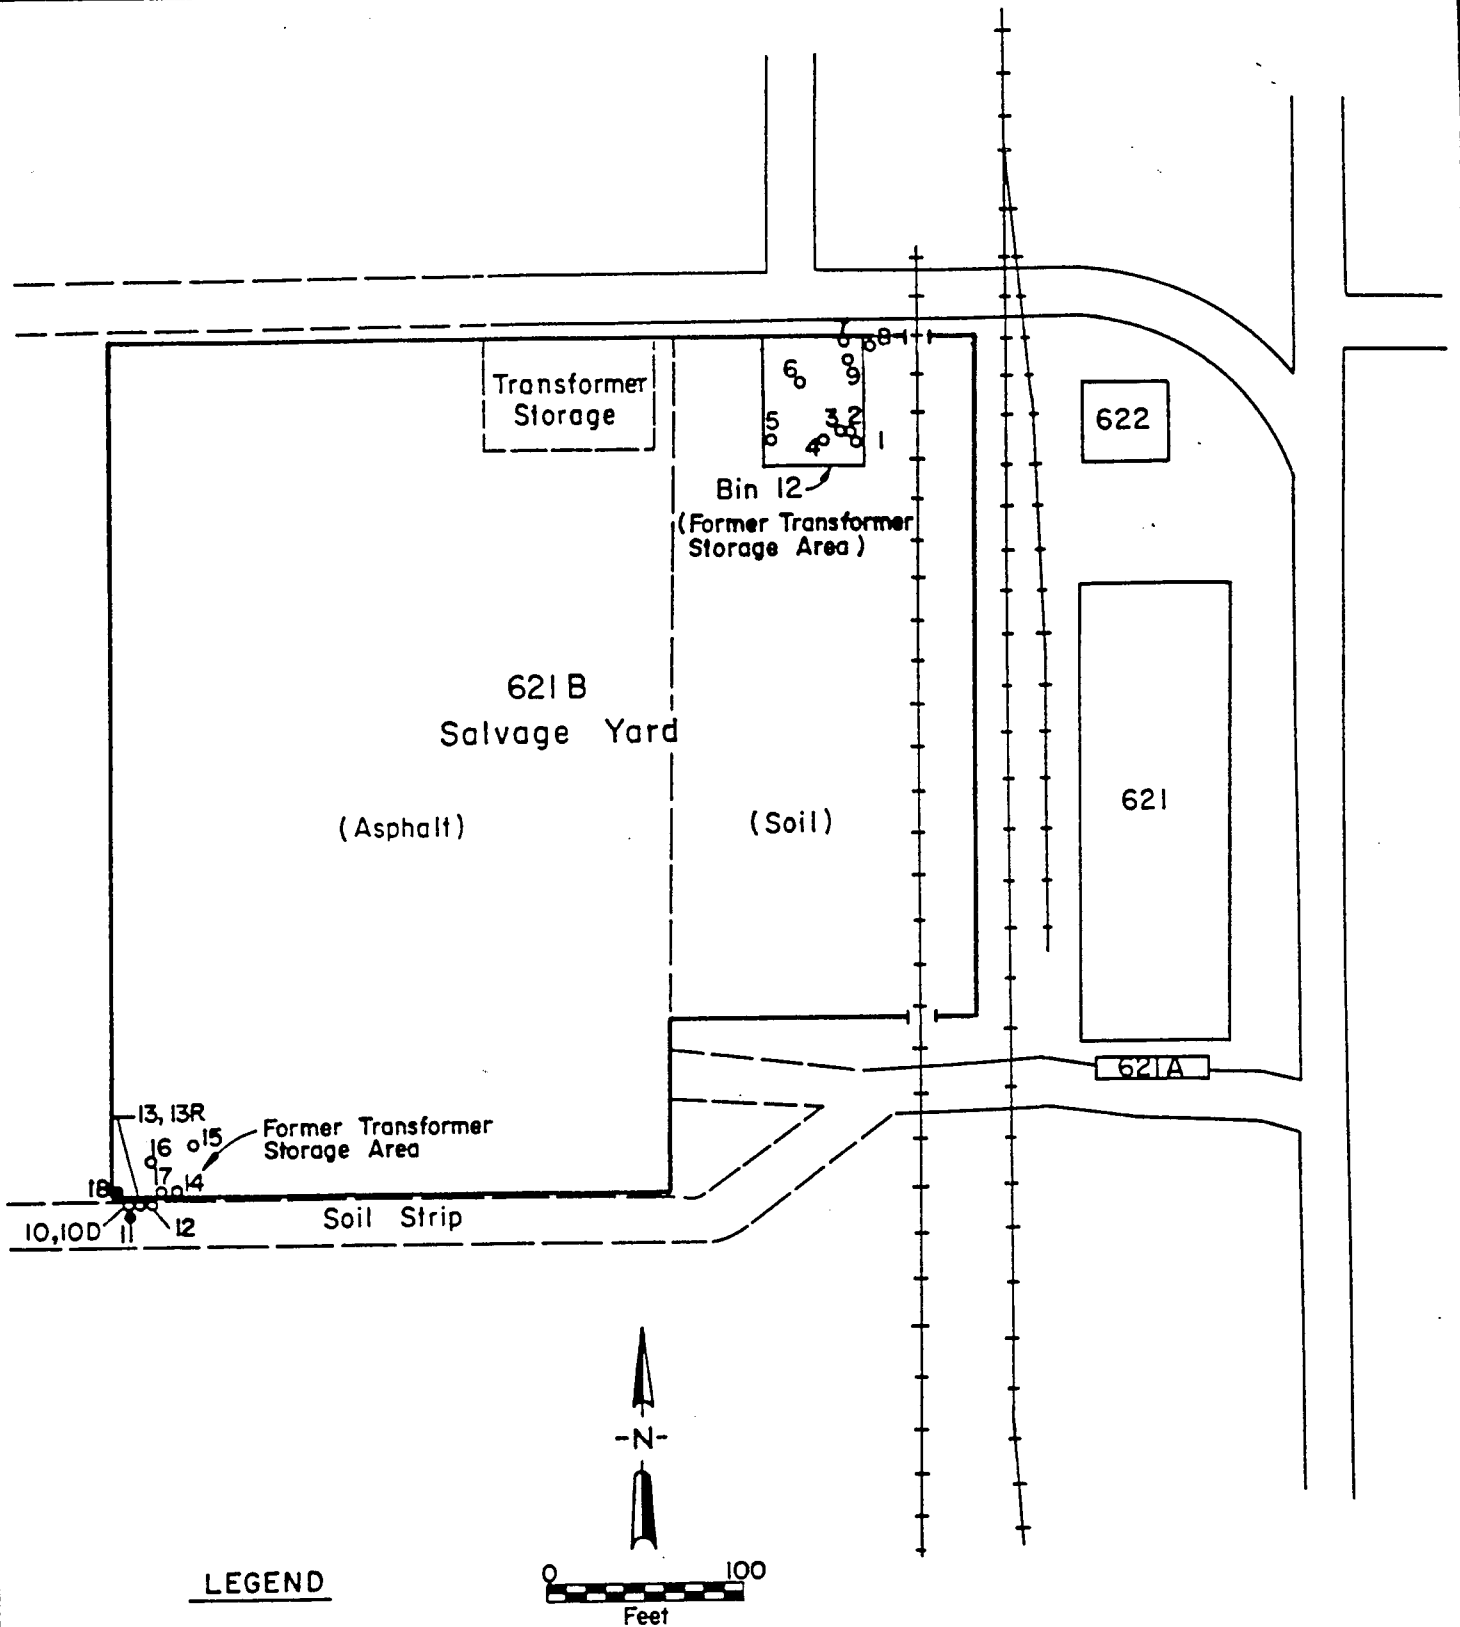
yard. The soil in the southeast corner of this bin is moderately stained. Eight 0 to 6 inch soil samples and one liquid sample of gear oil from a leaking container were taken from this area. A thin strip of stained soil lying immediately south of the southwest corner of the asphalt pad (edge of an old dirt road) was the second location sampled. Five soil samples at depths of 0 to 6 inches were obtained from this location, plus a rinse blank sample of the sampling equipment decon water (water used for decontamination of equipment). The third location sampled is the southwest corner of the asphalt pad where five distinct stained areas on the asphalt surface are visible.

PCBs were found above 50 ppm in the 0 to 6 inch interval of one soil sample from the soil strip south of the asphalt pad, and the 0 to 1 inch interval of one asphalt sample from the southwest corner. Both samples were obtained from the above mentioned former transformer storage locations within the 621B Salvage Yard.

As evidenced from the staining, a thin strip of soil (at one time, the northern edge of an old dirt road) lying immediately south of the southwest corner of the asphalt pad is believed to have served as a drainage receptor for any dielectric fluid or liquids leaking from the transformers previously stored on this portion of the asphalt pad. A concentration of 160 ppm in the 0 to 6 inch interval of Soil Sample (PCB)04621B2, and concentrations ranging from 6.8 to 26 ppm in adjacent soil samples (0 to 6 inch interval) from the immediate area further confirmed the release of PCB-bearing dielectric fluid into this portion of soil south of the asphalt pad.

The relatively low PCB concentrations (1.2 to 27 ppm) detected in soil samples from Bin 12 that accompany the minor staining observed in this soil also confirmed the release of PCB-bearing dielectric fluid from previously stored transformers into the soil of Bin 12; however, concentrations in this area were found to be below the 50 ppm storage and disposal standard. There will be no labelling or marking of equipment in accordance with 40 CFR 761 because equipment containing PCBs in concentrations of 50 ppm to 500 ppm was not found in the Group I buildings.

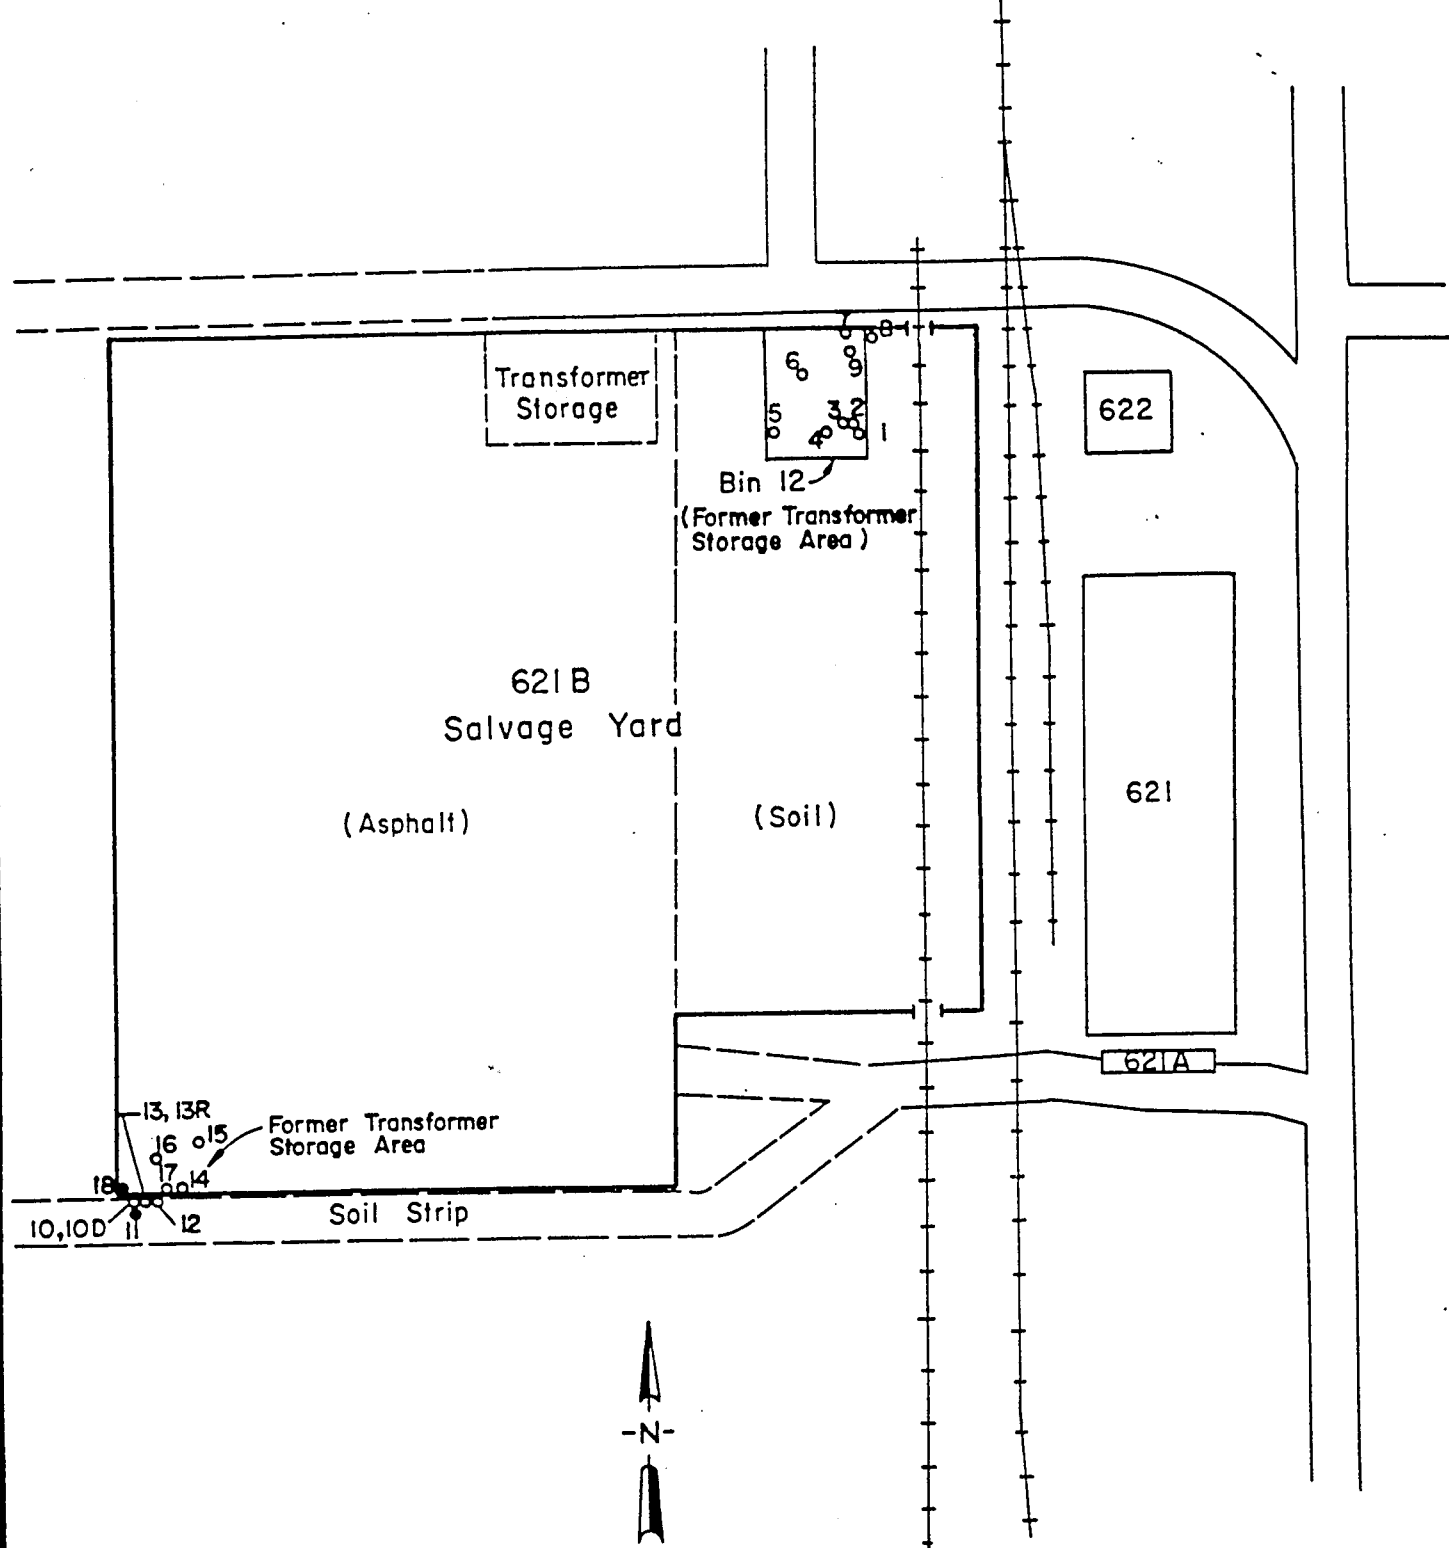
yard. The soil in the southeast corner of this bin is moderately stained. Eight 0 to 6 inch soil samples and one liquid sample of gear oil from a leaking container were taken from this area. A thin strip of stained soil lying immediately south of the southwest corner of the asphalt pad (edge of an old dirt road) was the second location sampled. Five soil samples at depths of 0 to 6 inches were obtained from this location, plus a rinse blank sample of the sampling equipment decon water (water used for decontamination of equipment). The third location sampled is the southwest corner of the asphalt pad where five distinct stained areas on the asphalt surface are visible.

PCBs were found above 50 ppm in the 0 to 6 inch interval of one soil sample from the soil strip south of the asphalt pad, and the 0 to 1 inch interval of one asphalt sample from the southwest corner. Both samples were obtained from the above mentioned former transformer storage locations within the 621B Salvage Yard.

As evidenced from the staining, a thin strip of soil (at one time, the northern edge of an old dirt road) lying immediately south of the southwest corner of the asphalt pad is believed to have served as a drainage receptor for any dielectric fluid or liquids leaking from the transformers previously stored on this portion of the asphalt pad. A concentration of 160 ppm in the 0 to 6 inch interval of Soil Sample (PCB)04621B2, and concentrations ranging from 6.8 to 26 ppm in adjacent soil samples (0 to 6 inch interval) from the immediate area further confirmed the release of PCB-bearing dielectric fluid into this portion of soil south of the asphalt pad.

The relatively low PCB concentrations (1.2 to 27 ppm) detected in soil samples from Bin 12 that accompany the minor staining observed in this soil also confirmed the release of PCB-bearing dielectric fluid from previously stored transformers into the soil of Bin 12; however, concentrations in this area were found to be below the 50 ppm storage and disposal standard. There will be no labelling or marking of equipment in accordance with 40 CFR 761 because equipment containing PCBs in concentrations of 50 ppm to 500 ppm was not found in the Group I buildings.
